Scintigraphy is the term used to describe the method of imaging the horse using an injected radioactive chemical. The most common application is in imaging the skeleton, or 'bone scanning' but in fact other organ systems can also be assessed using the same equipment and different biological markers.

SCINTIGRAPHY

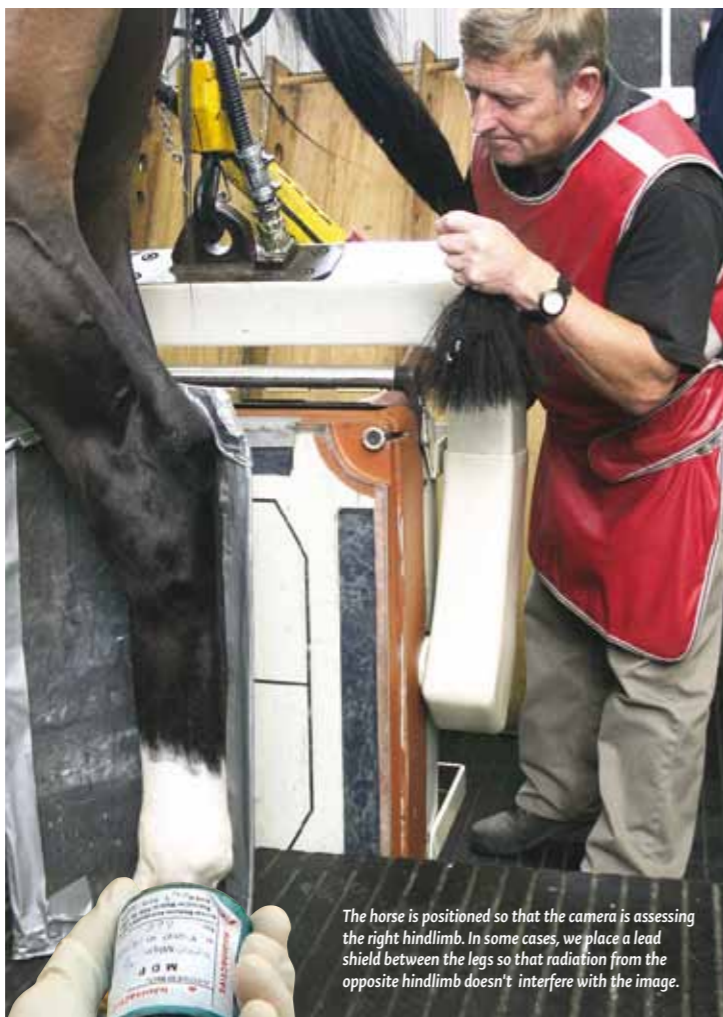
The horse is positioned so that the camera is assessing the right hindlimb. In some cases, we place a lead shield between the legs so that radiation from the opposite hindlimb doesn't interfere with the image.

detect the gamma rays being emitted by the horse's skeleton and convert these into pictures that are displayed on a nearby computer screen. The camera itself contains a single large crystal of sodium iodide, which is very thin and very delicate. Most of the bulk and weight of the camera comes from the shielding necessary to keep the crystal safe from damage and also to stop other sources of radiation, which are all around us, from interfering with the image quality. When the crystal is hit by a gamma ray it emits light - a tiny spark that is captured by photoelectric tubes behind the crystal and these sparks are passed on to the computer. The computer recognises the location of the tubes and because the brightness of the spark correlates to the intensity of the gamma rays, it can build an image of the region of interest. This image gives us an accurate map of the activity of the bones - it is measuring physiological activity at the moment of the examination (unlike x-rays, which give us the evidence of what has been happening to the skeleton over weeks, months and even years).
